The Dalles Dam Fishway Status Report

2/28/2015

Inspection Period: 2/22/2015 to 2/28/2015

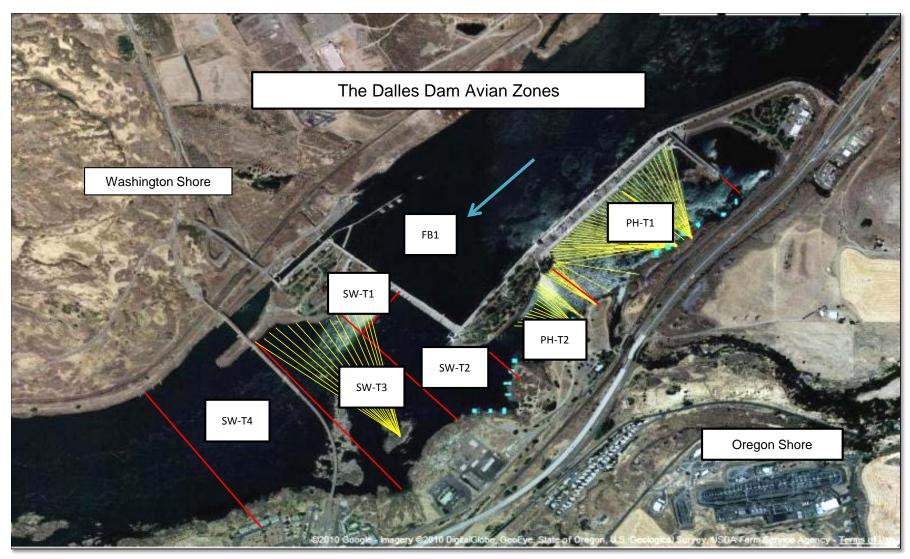
Bird observation data collected once daily. Few eagles remain. Refer to Avian Zone Map.

Avian lines in yellow, zones in red, river flow in blue.
