# The Dalles Dam Fishway Status Report

05/10/2020

Inspection Period: 5/03-5/09

US Army Corps  
of Engineers  
Portland District

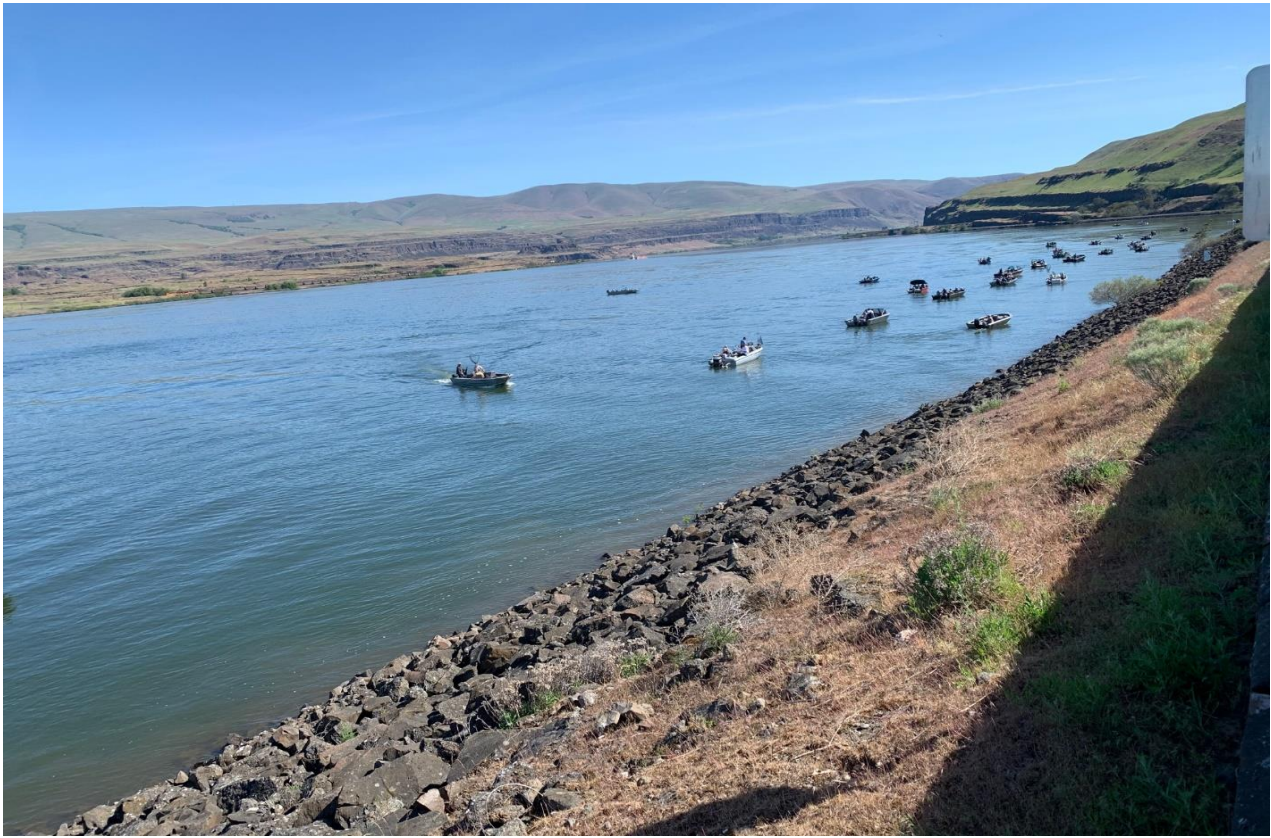
Numerous fishermen upstream of east exit during the several days of open season. Refer to pic. All seemed to respect the boundary.

Fishermen along shoreline upstream of east ladder exit.
