# The Dalles Dam Fishway Status Report

11/15/2020

Inspection Period: 11/8 - 11/14

# THE DALLES DAM

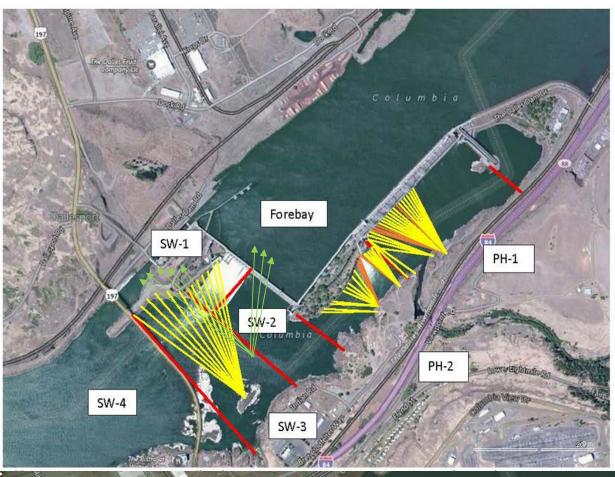
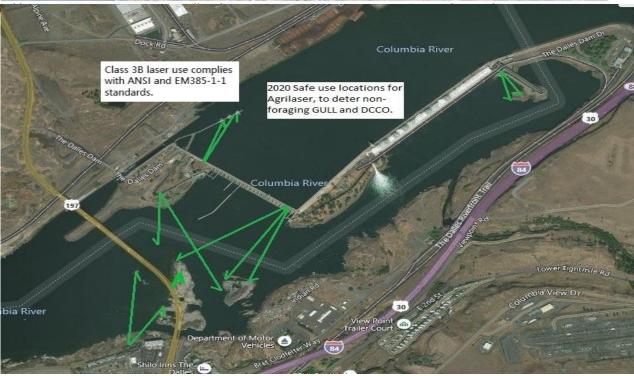
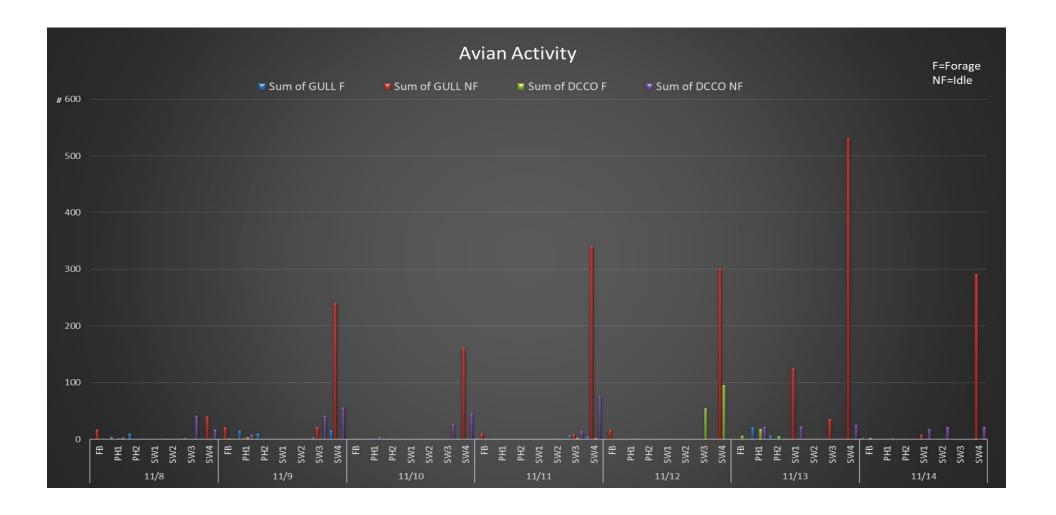
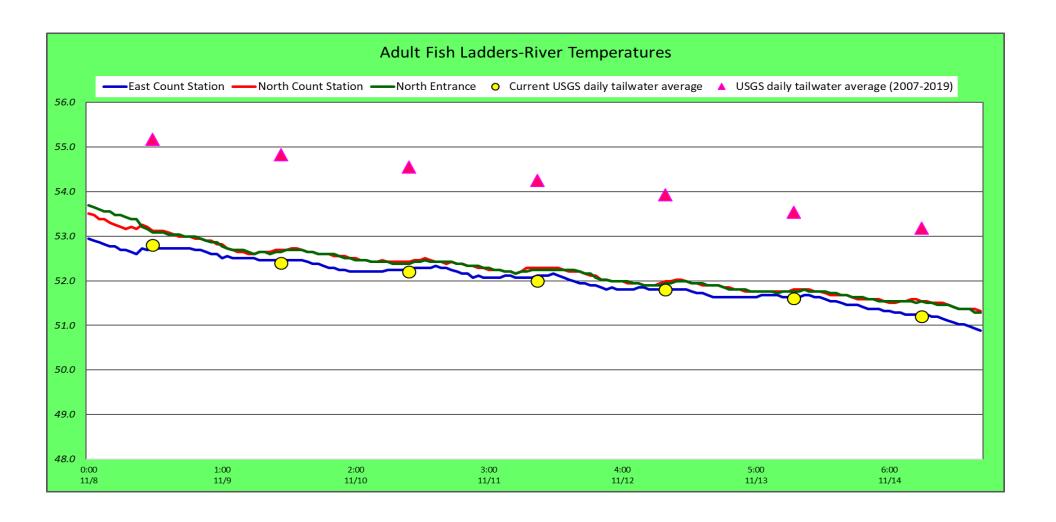
# New Avian Lines and laser deterrent zones

Green laser use for piscivorous bird hazing testing continues. Effective tool for roosting birds during low light.

Cormorants foraging forebay near east ladder exit and entrance. Several herons foraging east fishladder. Three hours observation, one dip, no catch. Invasive aquatic weeds significant at count station pickets and north exit.

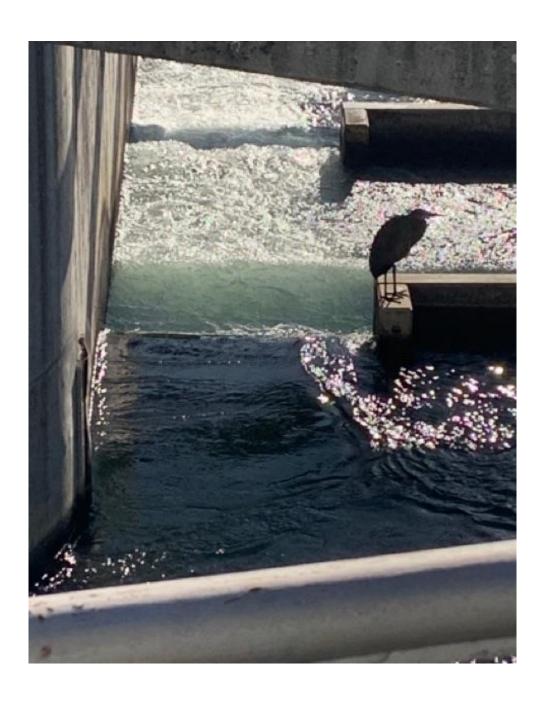
GoPro video recordings made of GBHE in east ladder fishway. No prey taken during 3 hours
