# The Dalles Dam Fishway Status Report

Inspection Period: 1/23 - 1/29/2022

## THE DALLES DAM

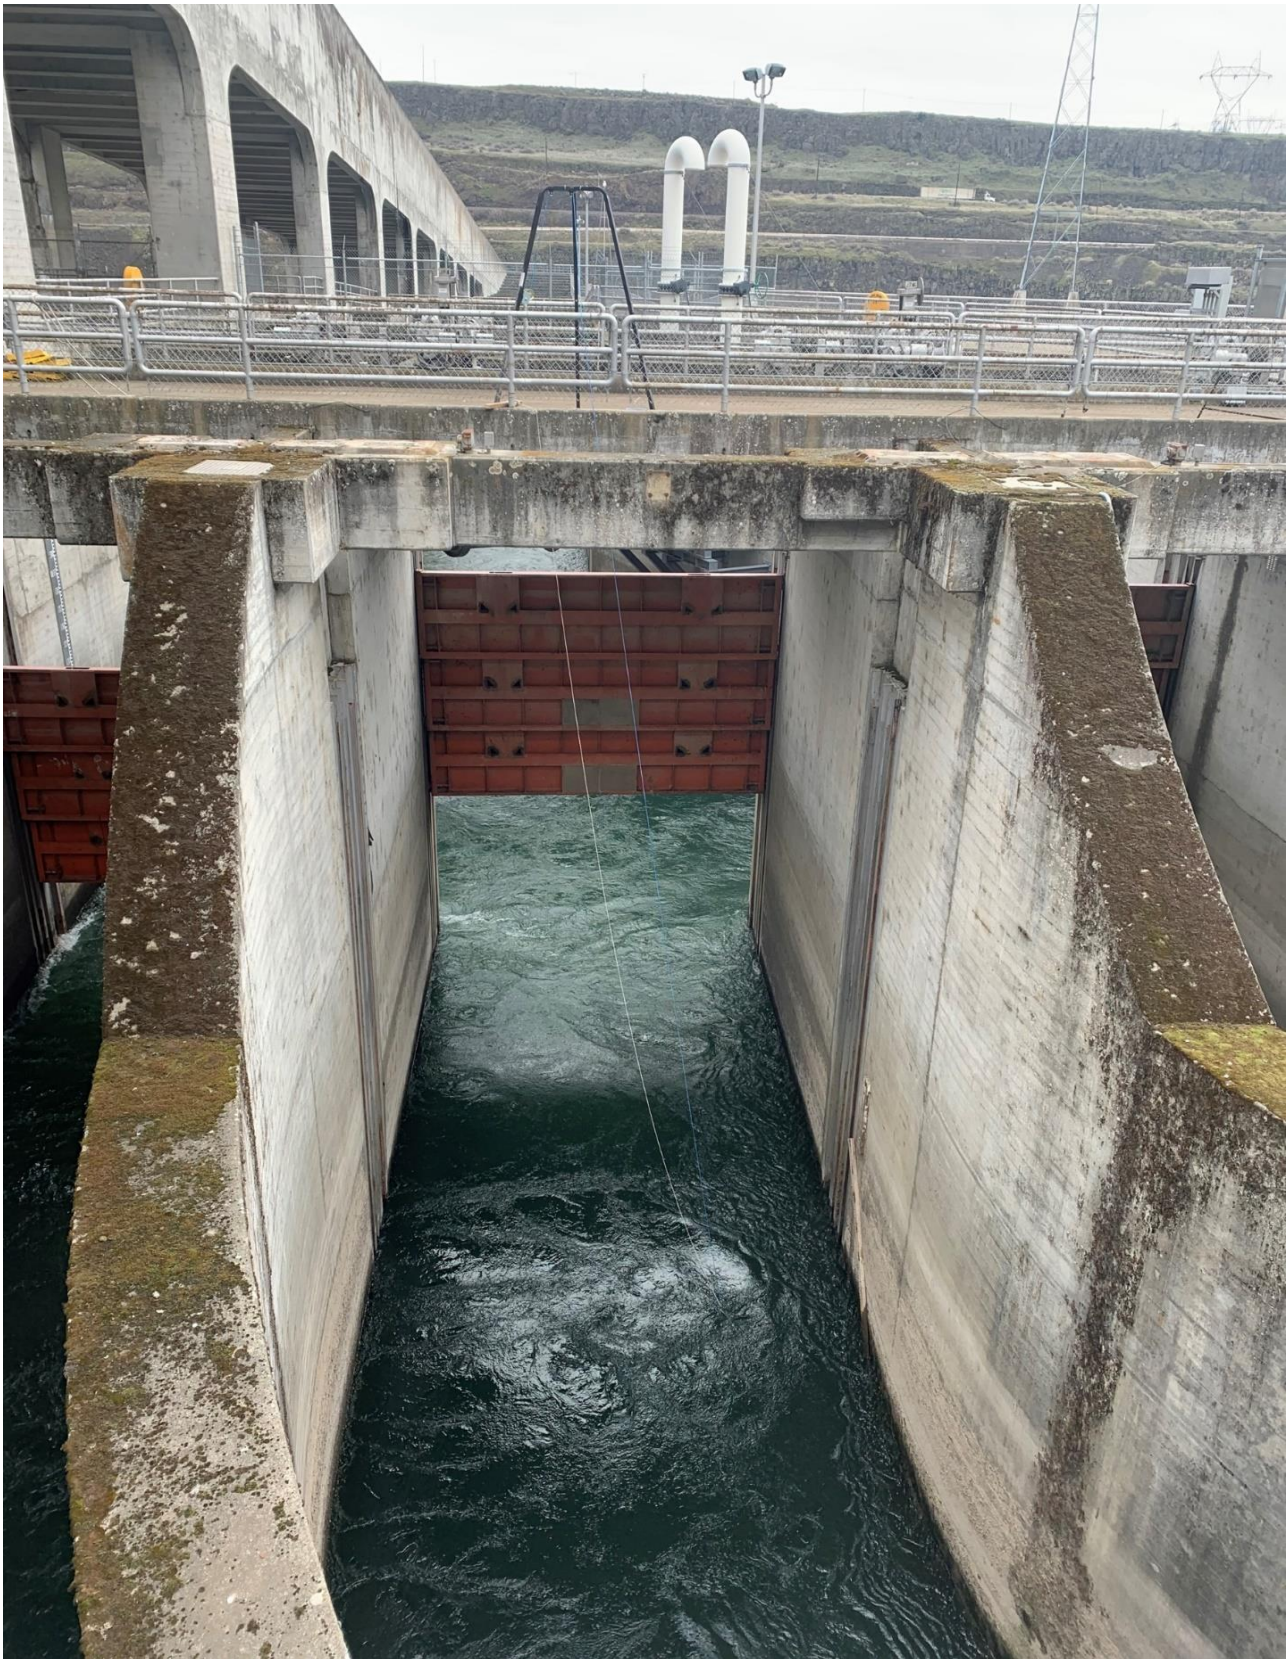
New General Oceanic mechanical flow meter sampling site at the east end of the collection channel 1/28/2022.

Velocity measurements made repeatedly using new flow meter comparing with float time method. Considering options to impliment.  
East fishway in full service. North dewatered for annual maintenance.  
Ice Trash sluiceway endgate closed. MU1 and 18-3 intakes opened for fish egress.
