The Dalles Dam Fishway Status Report

Inspection Period 12/11-12/17, 2022

THE DALLES DAM

US Army Corps
of Engineers
Portland District

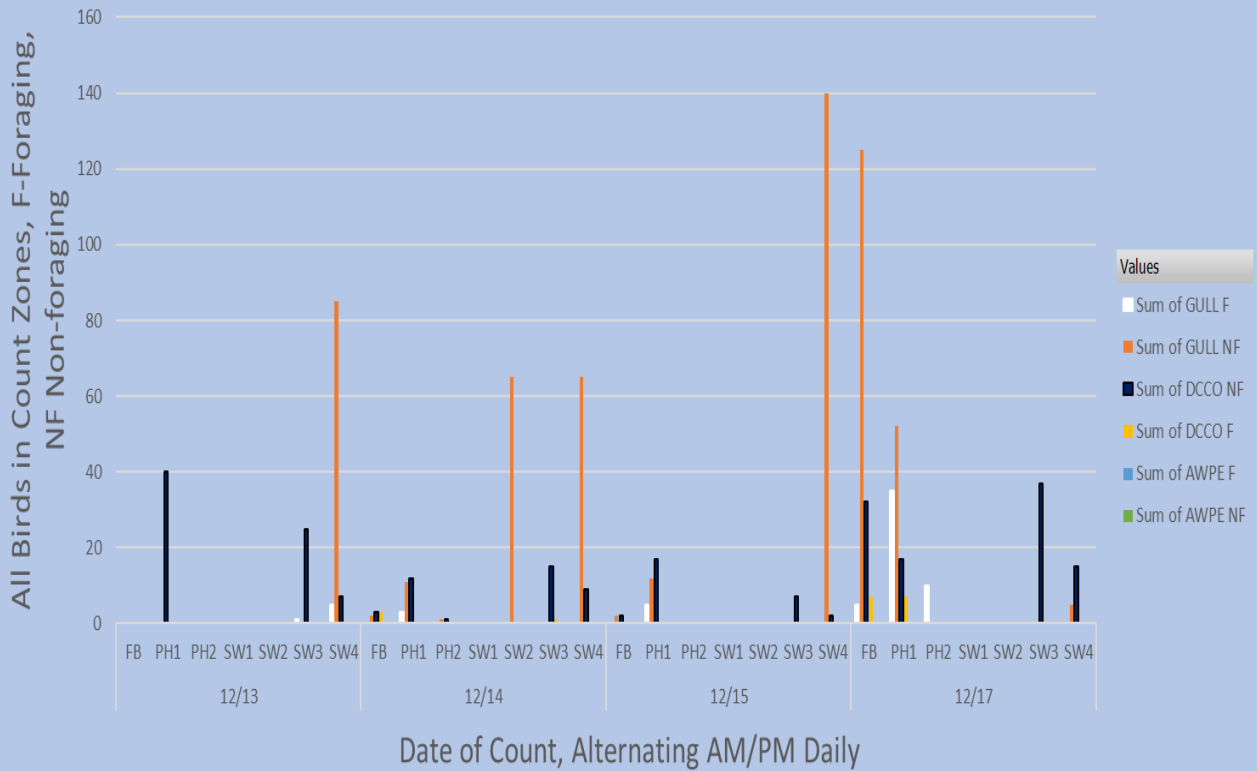
Avian Count at TDA, 12/13 to 12/17/2022

The Eagles have landed. Reducing numbers of western gulls significantly. Handfull of California gull scouts overflying daily.

Resident cormorants foraging around project, 50-80 common mergansers getting shad in PH1.

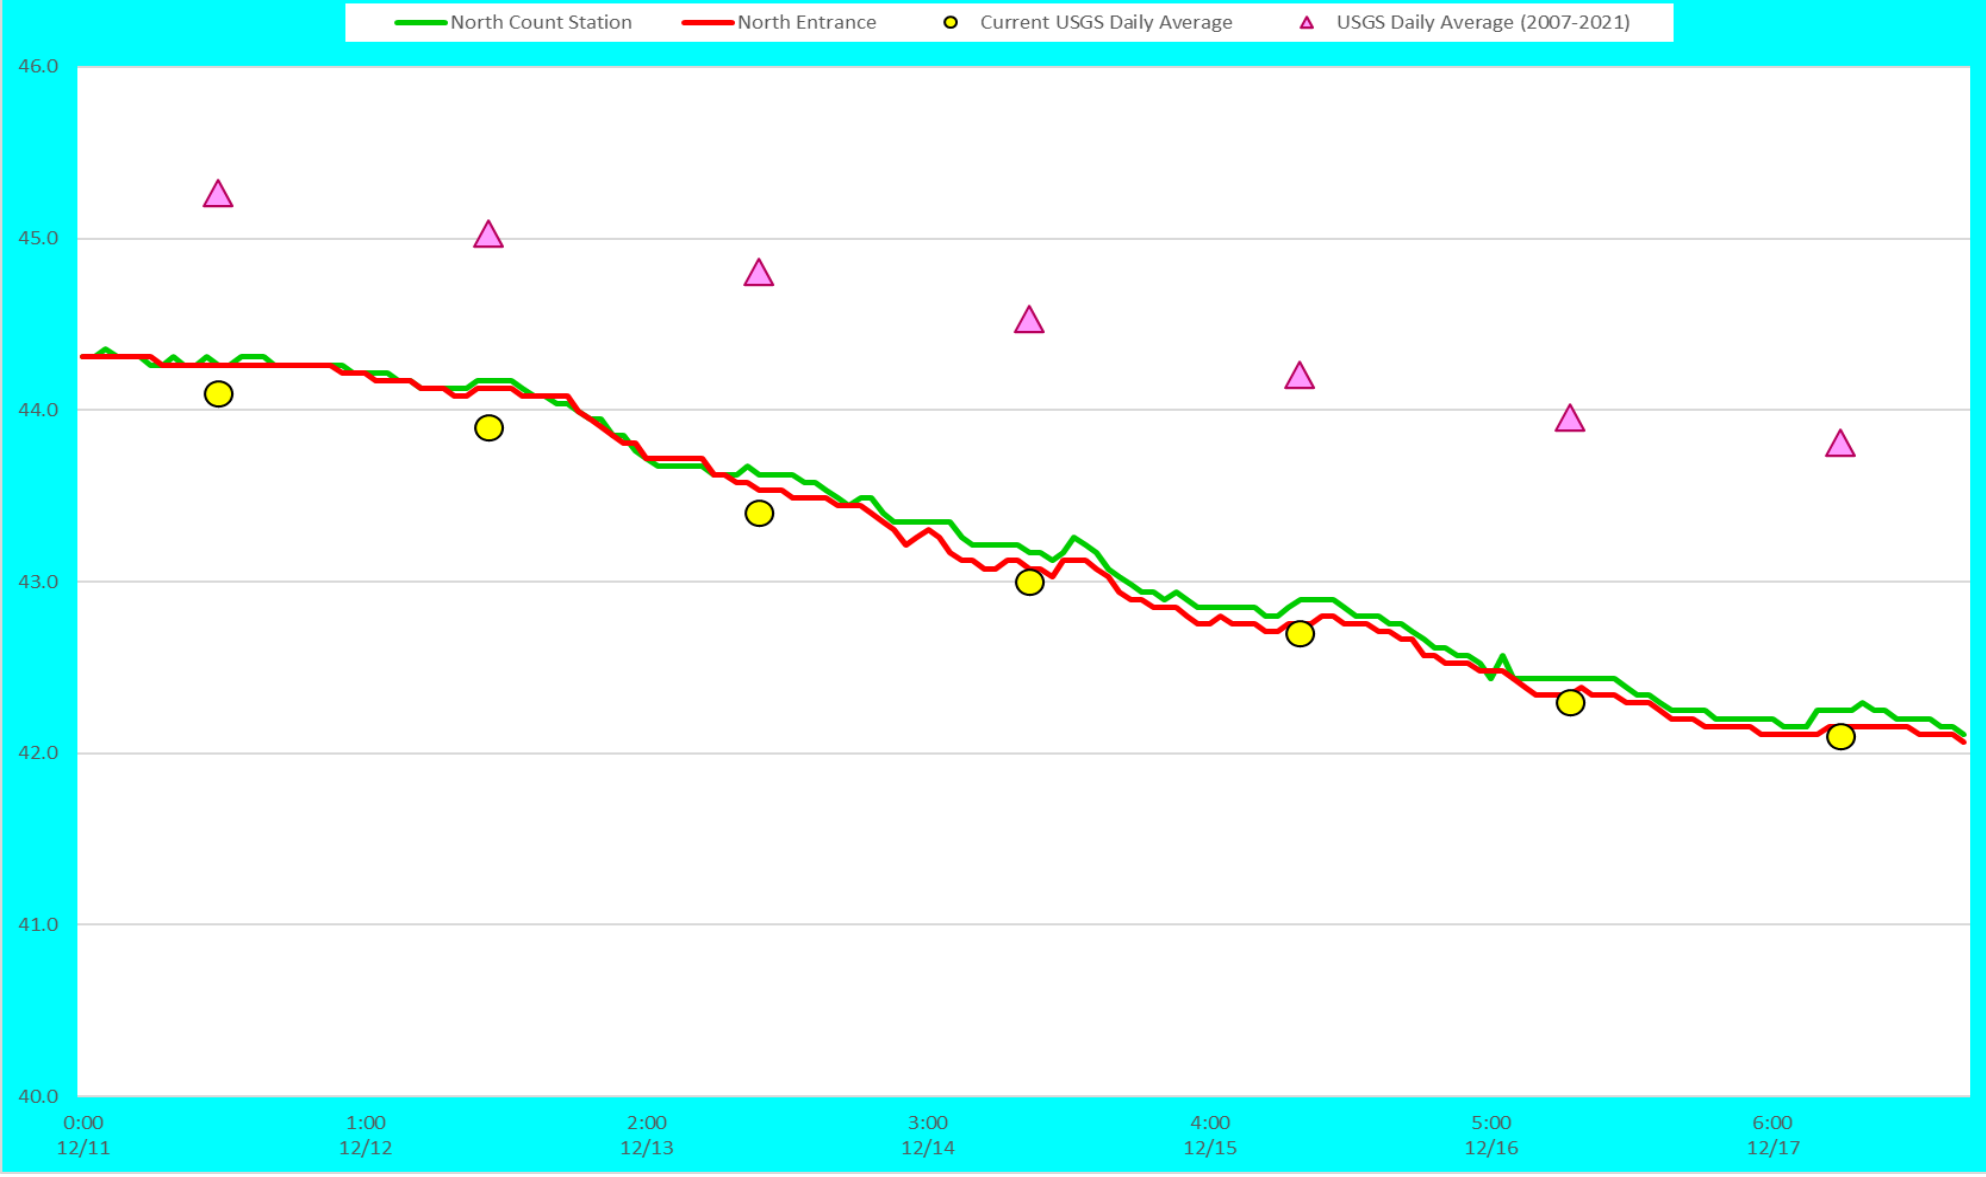
North Fish Ladder-River Temperatures

Secchi:		USGS°F
5.0	Sun	44.1
5.0	Mon	43.9
5.0	Tue	43.4
5.0	Wed	43.0
5.0	Thurs	42.7
5.0	Fri	42.3
5.0	Sat	42.1
5.0+	AVG	43.1

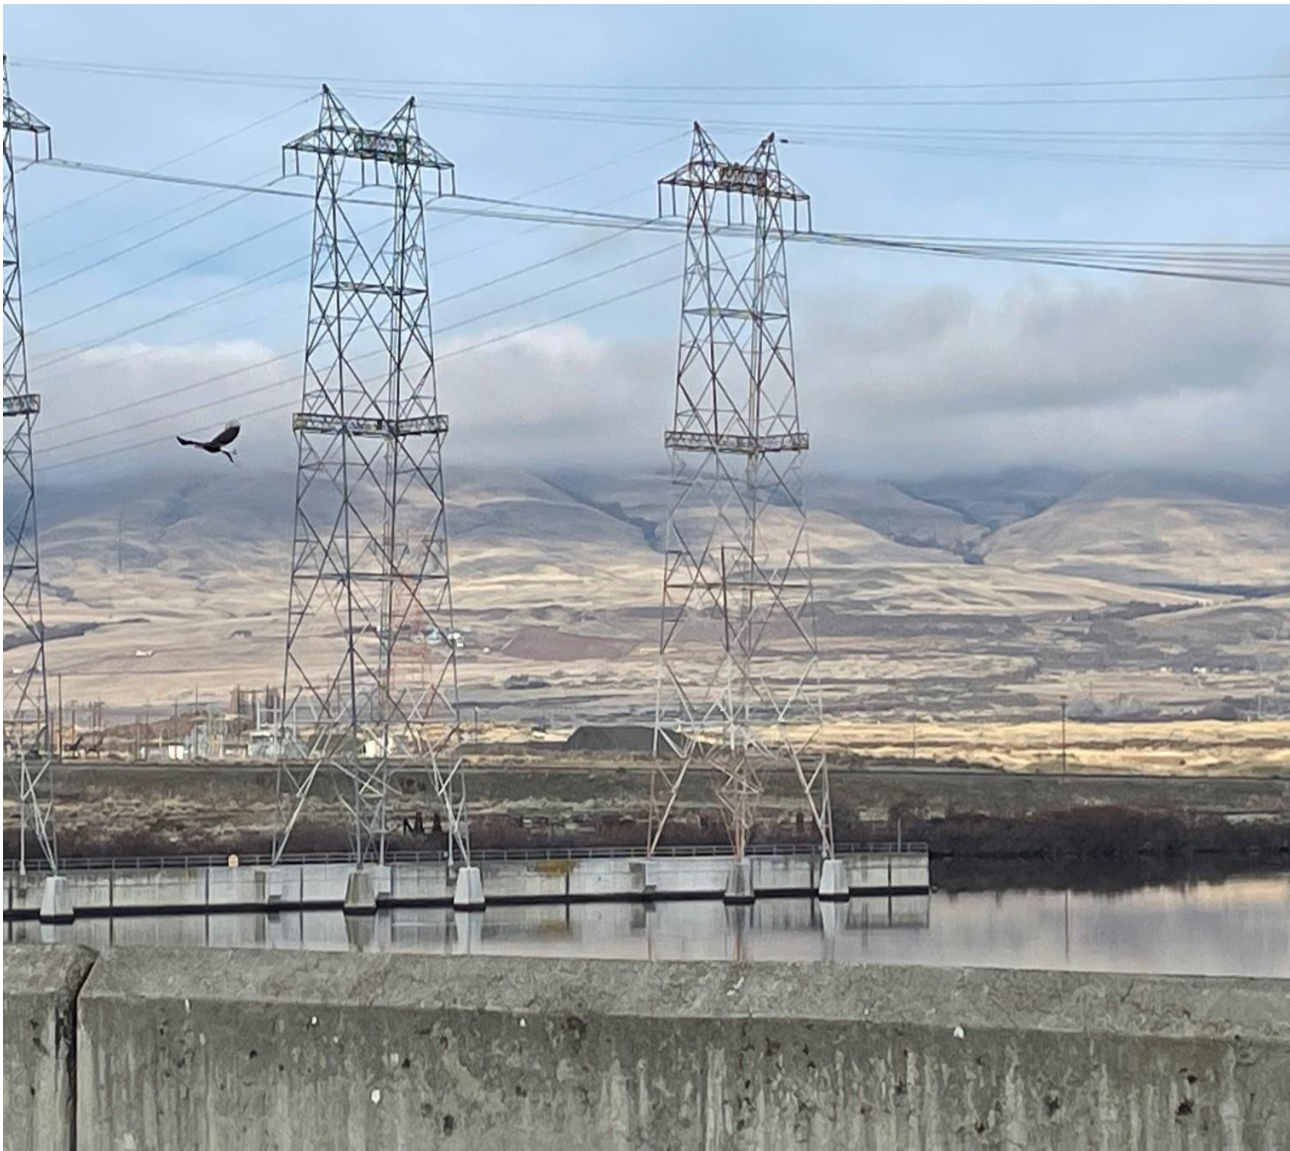
Bald eagles are here to feed on adult shad and keep other shad eaters away.
