# The Dalles Dam Fishway Status Report

Inspection Period 6/9 - 6/15, 2024

## THE DALLES DAM

US Army Corps  
of Engineers  
Portland District

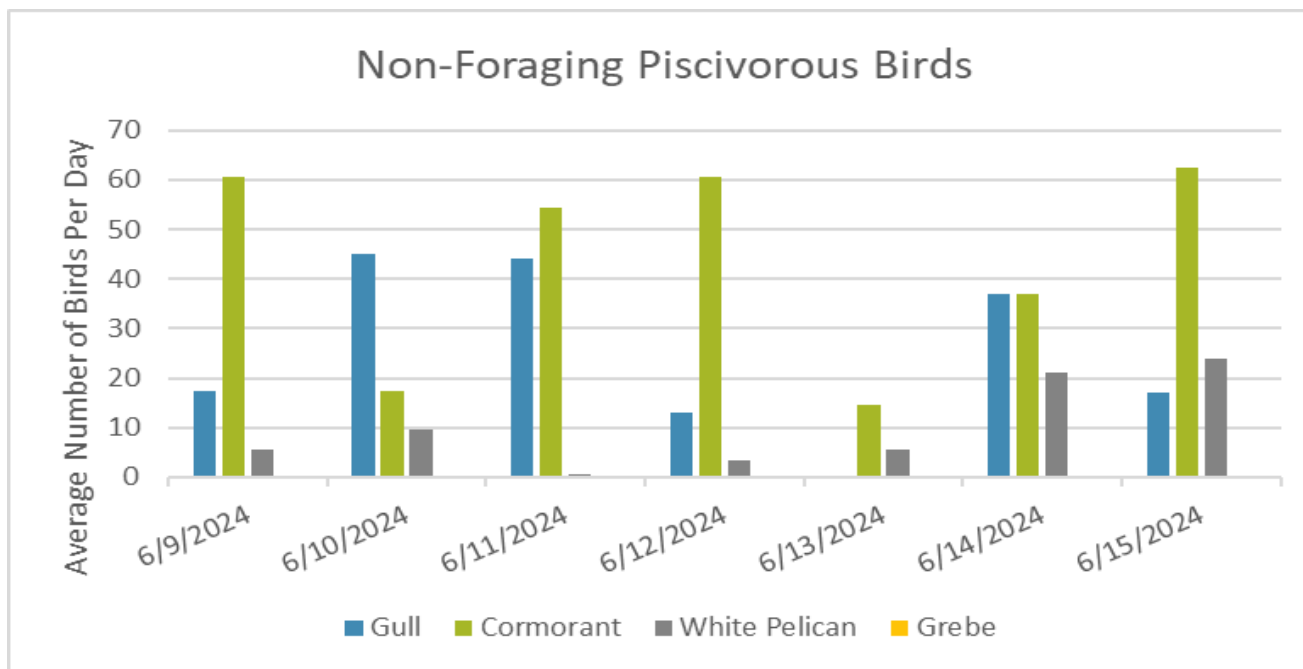
Counts are usually taken before the beginning of active hazing and typically after the end of daily hazing around 1400 hrs. USDA does one daily count in all zones and USACE does additional count in all zones.

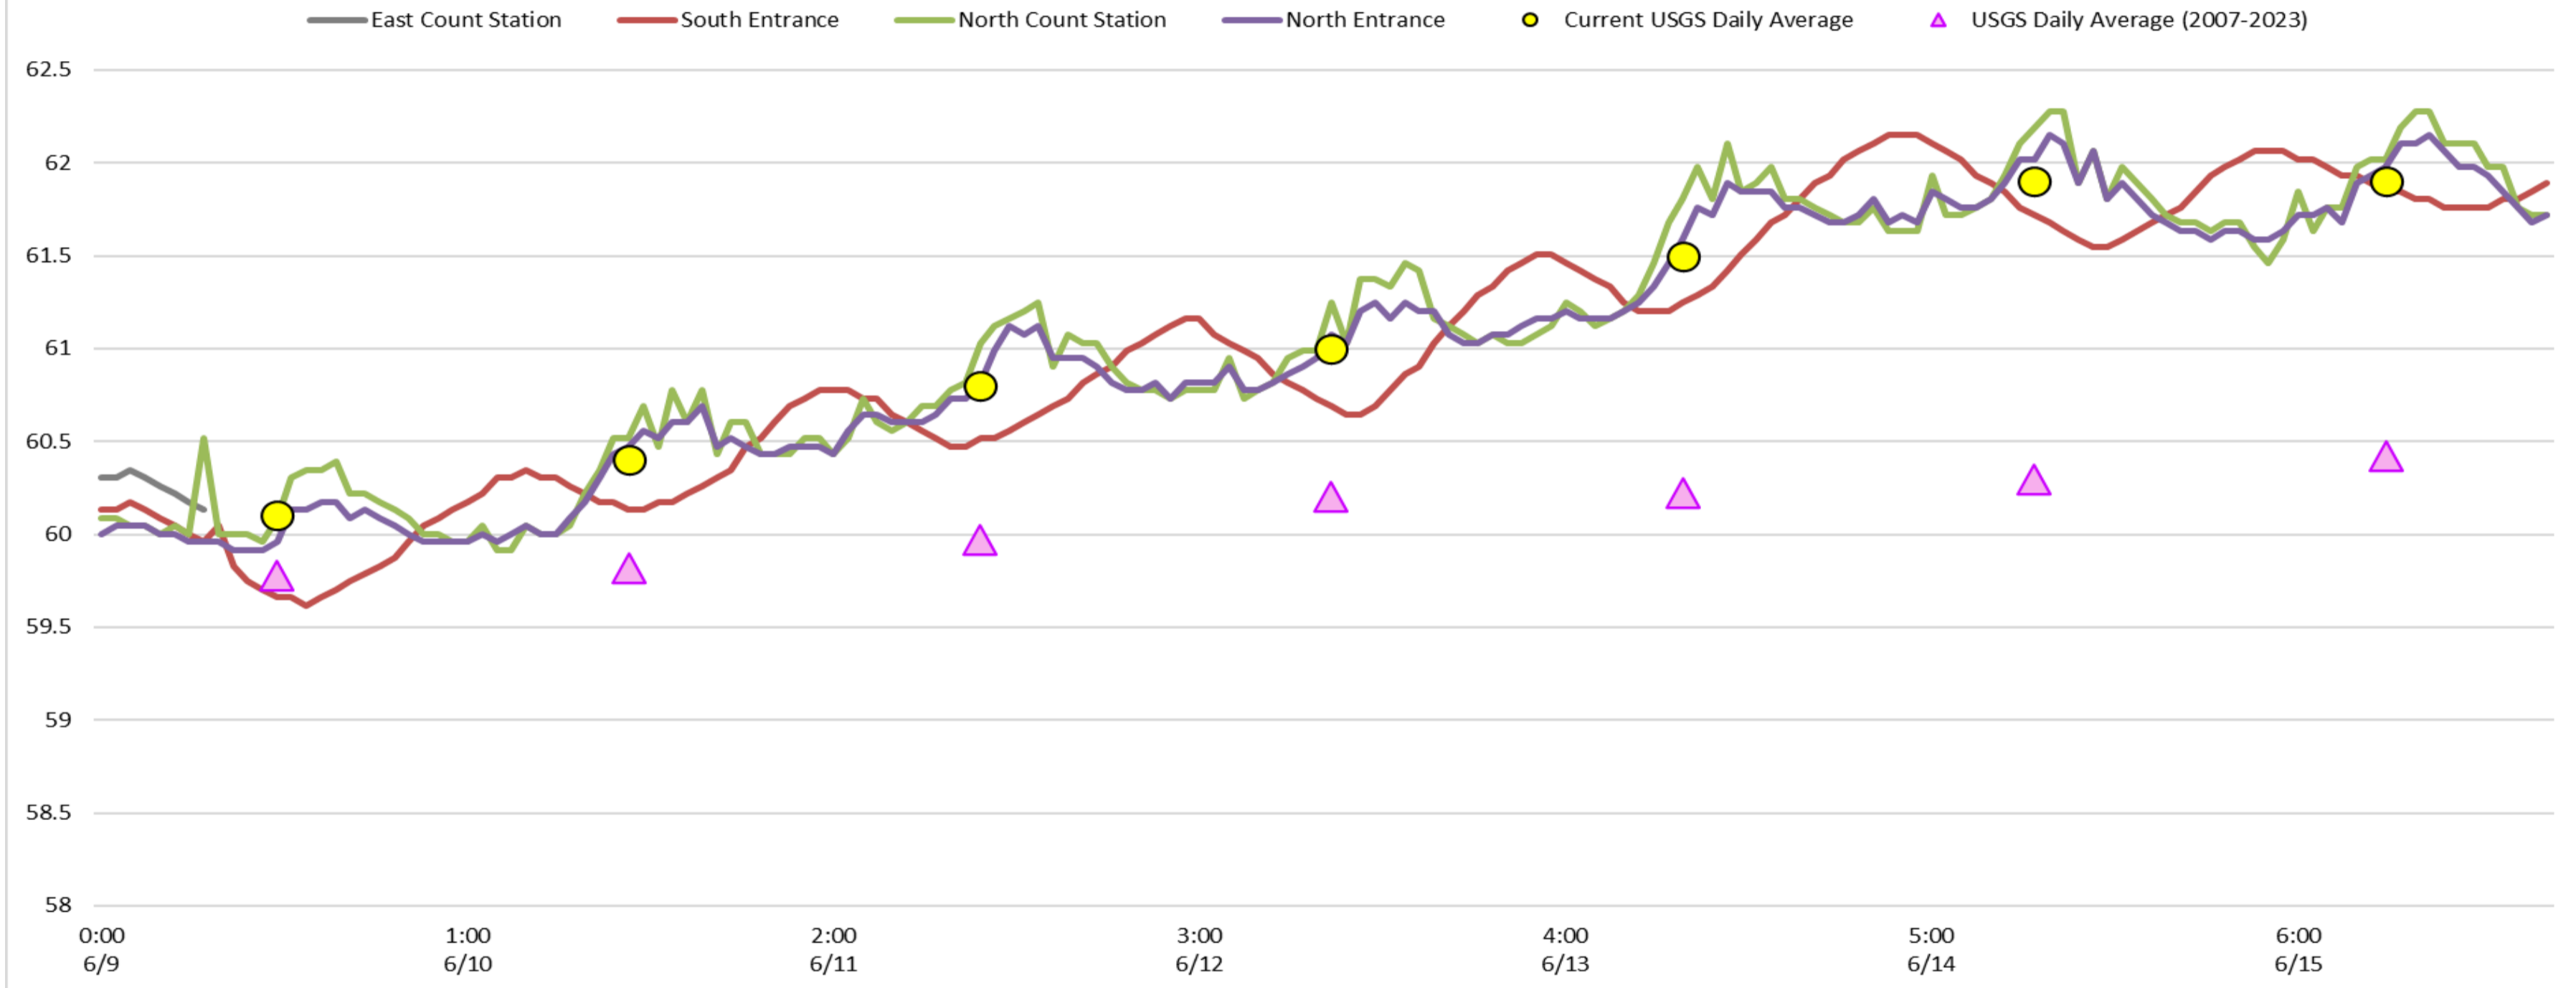
### Adult Fish Ladders-River Temperatures

Secchi:		USGS
5.0	Sun	60.1
5.0	Mon	60.4
5.0	Tue	60.8
5.0	Wed	61.0
5.0	Thurs	61.5
4.5	Fri	61.9
5.0	Sat	61.9
4.9	AVG	61.1
