FISHWAY STATUS REPORT

Date: 01/08/2012
 Inspection Period: 01/01/12 - 01/07/12

THE DALLES DAM

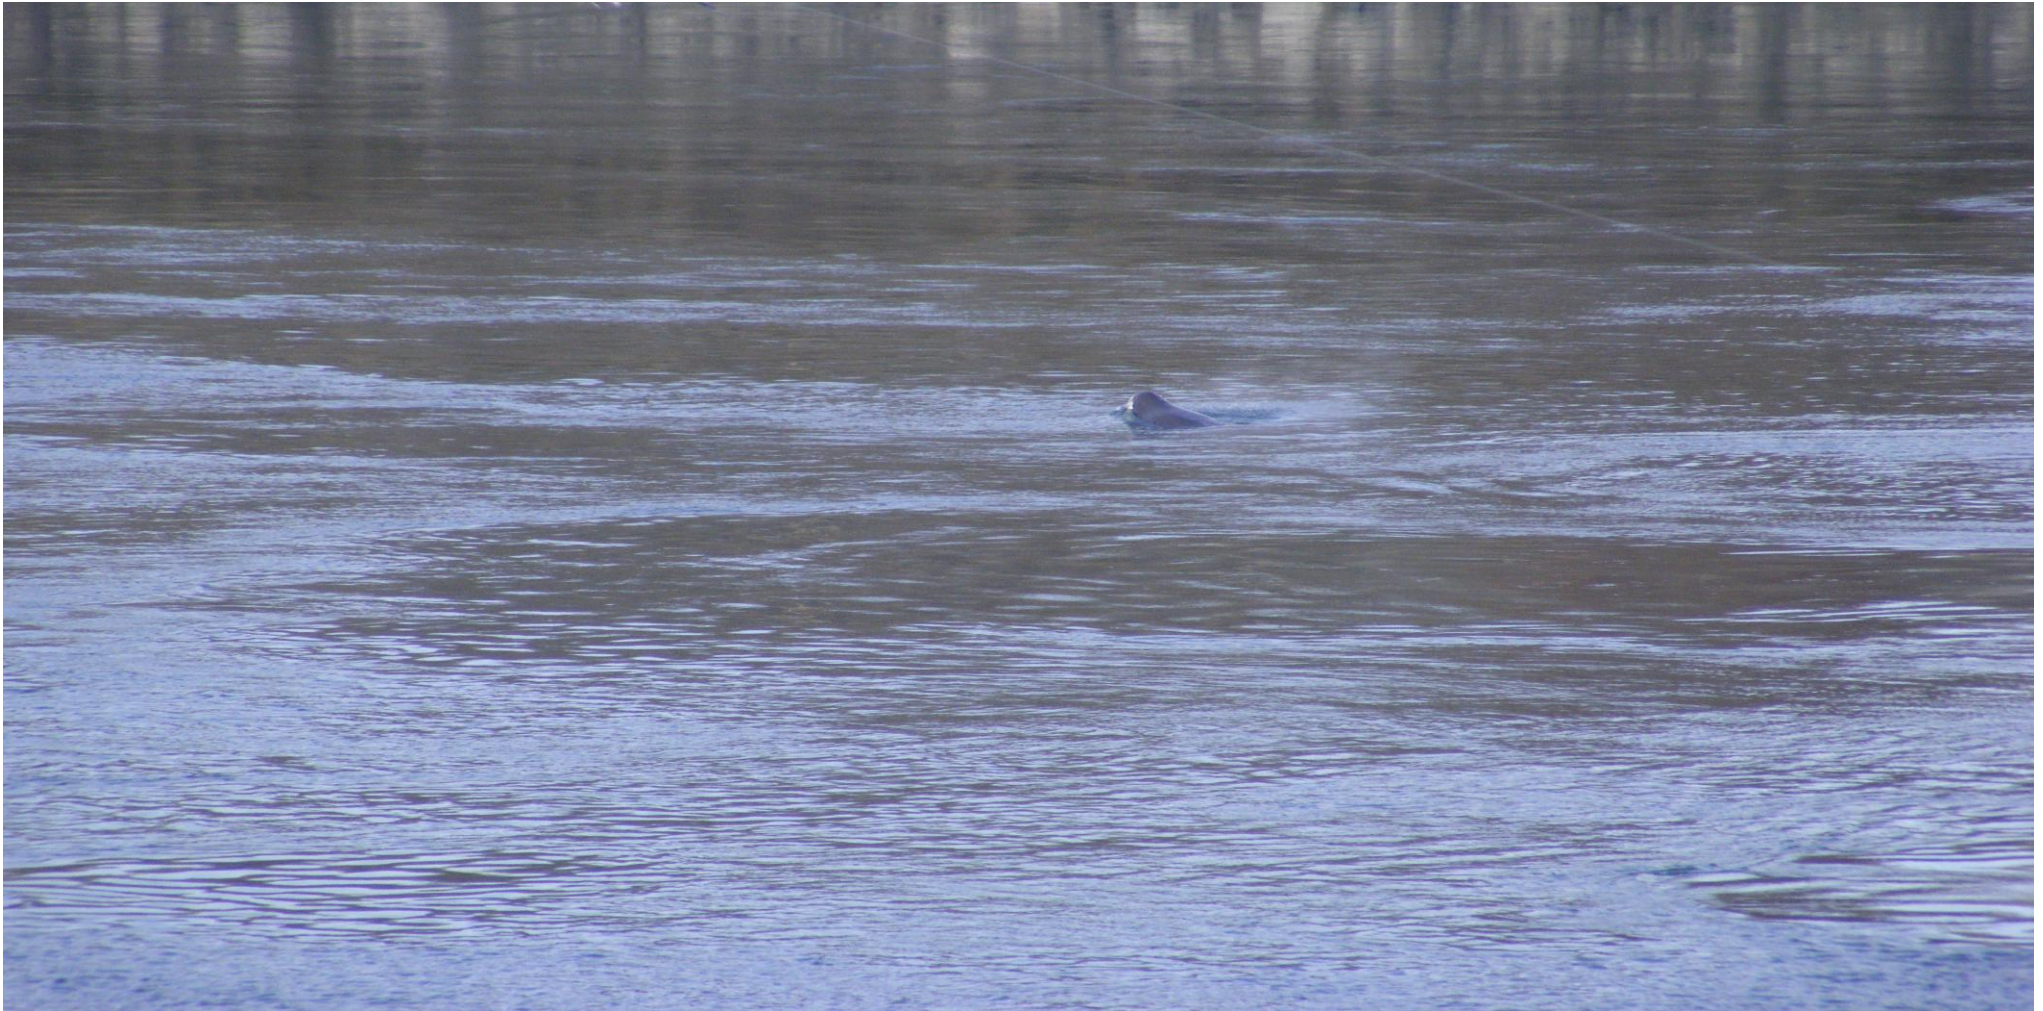
After frequent 'Nessie' sightings, the monster was identified as a rogue california sea lion imported from Bonneville Dam. Several fish takes were verified, but fish species could not be identified.
